OFFICE OF THE INSPECTOR  
OF CUSTODIAL SERVICES

Physical Infrastructure  
Review Paper

**Banksia Hill Directed Review  
August 2013**

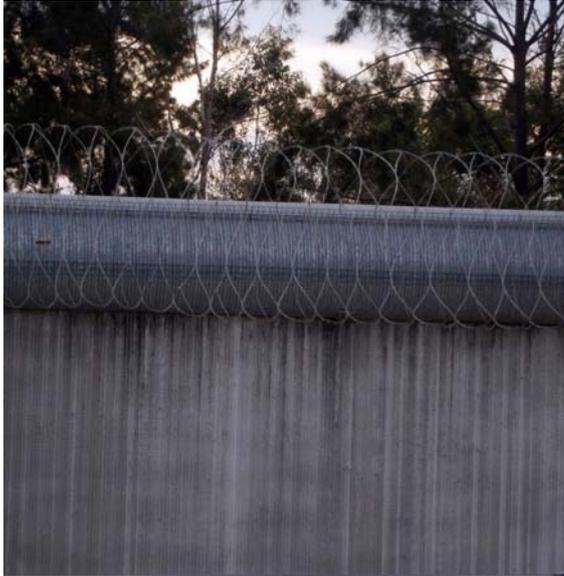
**Photo 15**

*Detail of razor wire added to the perimeter wall soon after completion of the early construction works as a result of security testing.<sup>9</sup>*

<sup>9</sup> It does not appear that other less lethal solutions were considered.

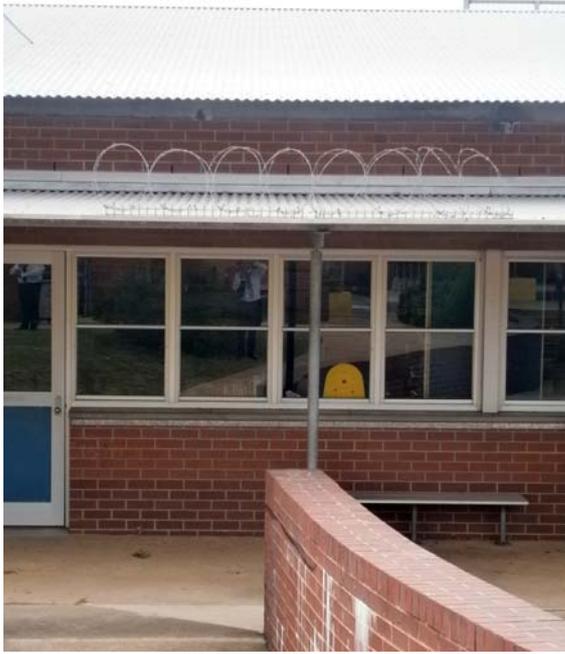
**Photo 18**

*Placement of razor wire to discourage roof ascents from adjacent low height wall.*

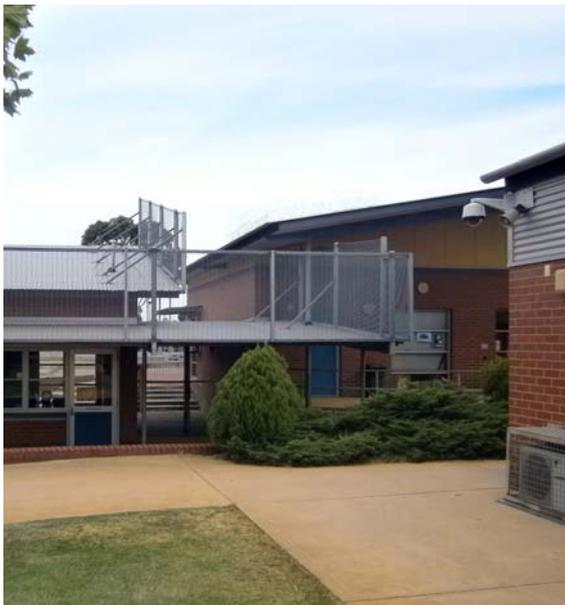
**Photo 19**

*Barriers installed at roof edges to discourage ascents. Raised levels alongside roof edges make the roofs vulnerable to opportunistic ascents.*

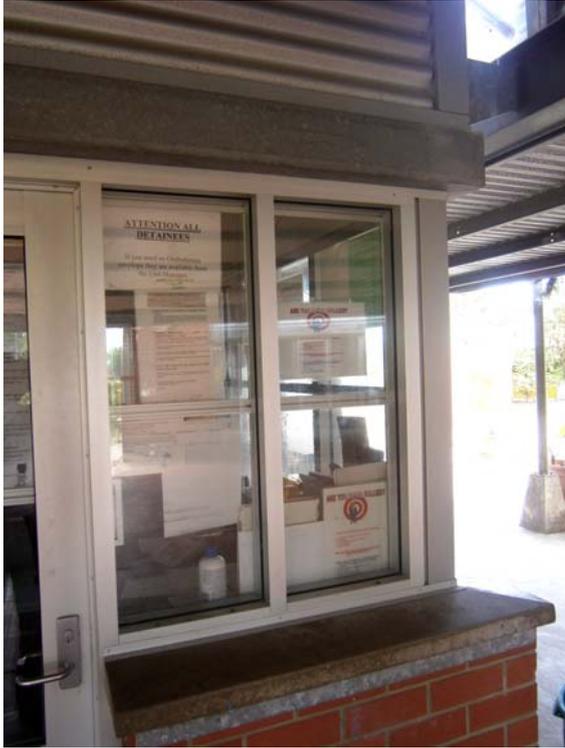
**Photo 20**

*Notices placed over staff base windows. This significantly reduces sight lines and does not assist engagement of staff with detainees (see also Photo 21).*

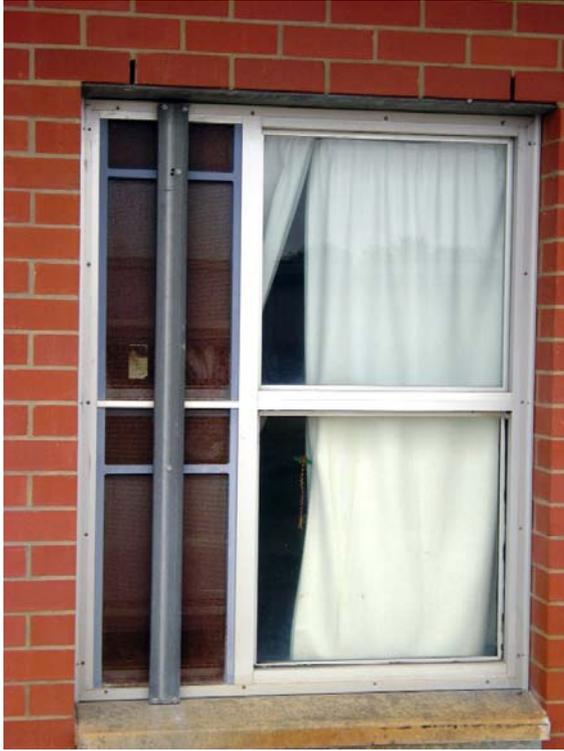
**Photo 22**

*Early retrofit in reaction to a breach of the cell through a broken window sash – cell furniture was used to break the sash.*

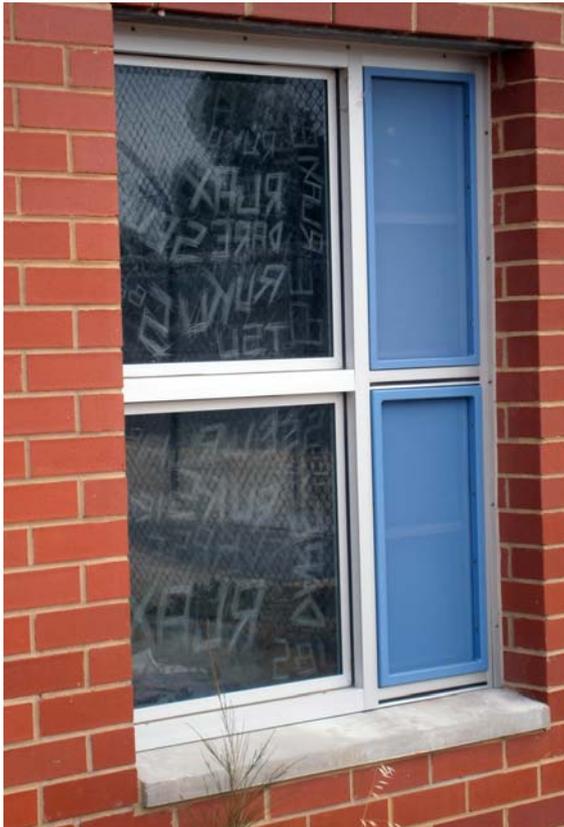
**Photo 23**

*Modifications to a window in the Harding Unit Wing.*

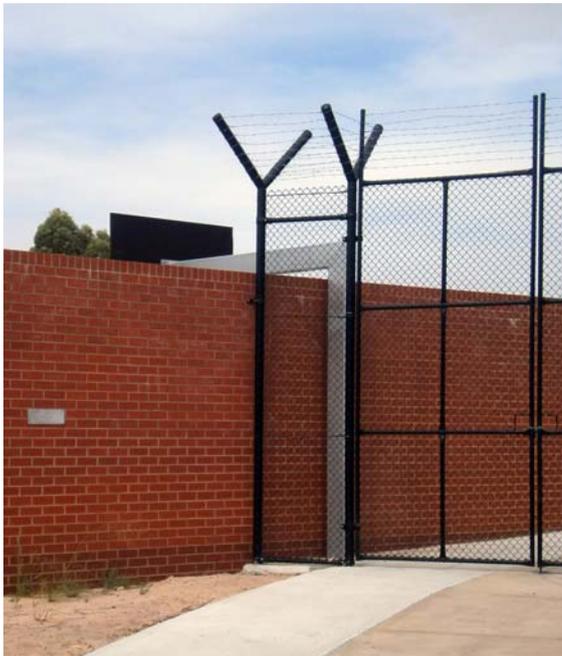
**Photo 25**  
*Illogical adjacency to provide continuity of management enclosure.<sup>10</sup>*

<sup>10</sup> There is a lack of continuity in the effective climbable height as a result of butting a high fence with barbed wire against a lower wall without wire. The chain link mesh provides an easily scaled surface which can be used to gain access to the top of the wall.

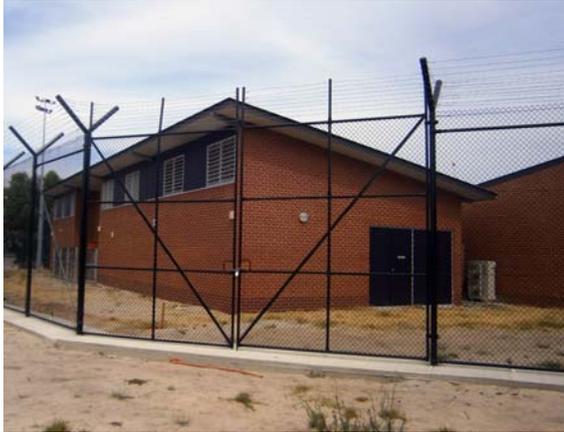
**Photo 26**  
*Illogical continuity of fence top configuration.<sup>11</sup>*

<sup>11</sup> The fence's 'Y' shaped top is harder to negotiate than the straight top of the gate. The gate was scaled by detainees, assisted by the gate frame providing a natural foot-hold. This configuration negated the benefit of the additional expense of the 'Y crank'.

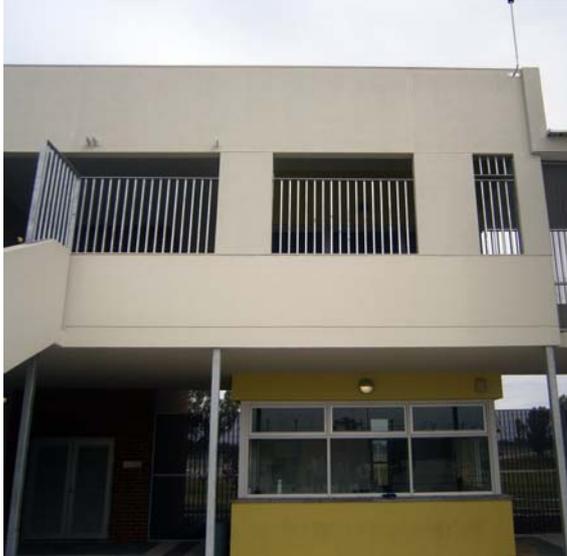
**Photo 29**

*Grilles introduced in reaction to perceived concerns about injury of people falling from upper levels.*

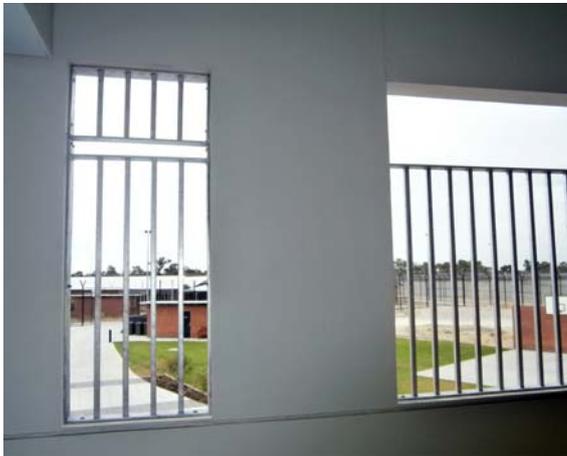
**Photo 30**

*Illogical application of grilles – ‘gaps or no gaps?’*

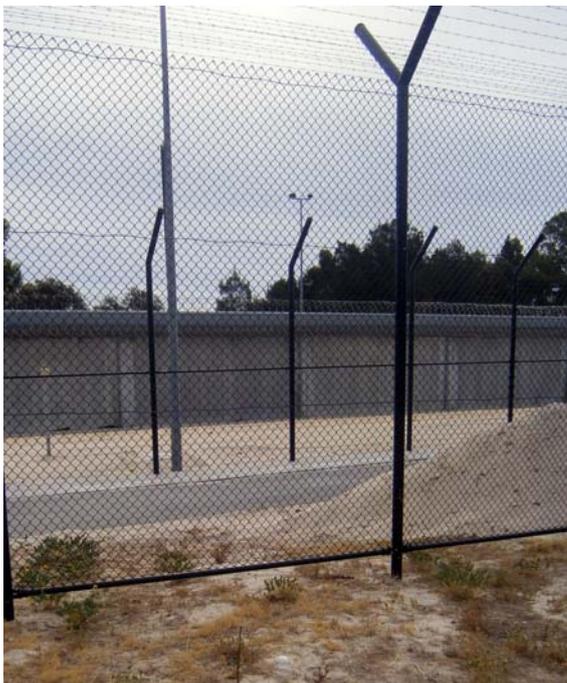
**Photo 31**

*It is easy to crawl below the fence with no concrete plinth.*

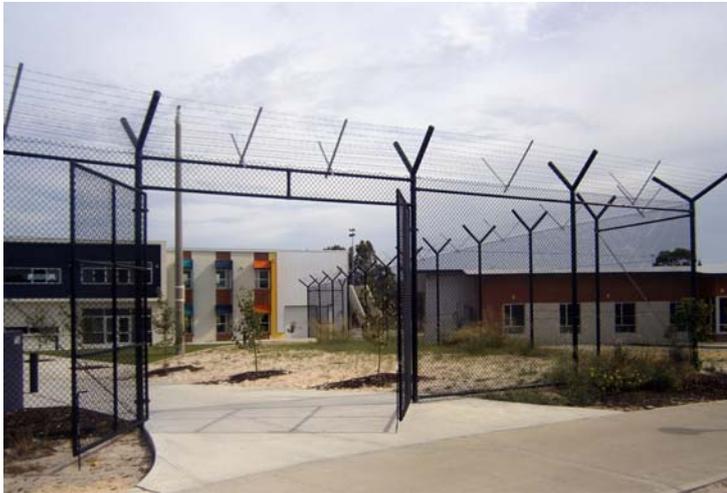
**Photo 32**  
*Management fencing to the new boys unit. Gates in management fences need to be controlled and managed effectively or they get left open and defeat the original purpose of installation.*

5.13 Photos 32 to 34 show the management fencing around the most recently constructed boys' unit at Banksia Hill. This fence type was easily scaled by detainees during the riot, rendering them as 'demarcation' rather than 'barrier' fences. The issues surrounding the adding of lethal layers to fences in juvenile facilities is covered elsewhere in the Inquiry.<sup>13</sup>

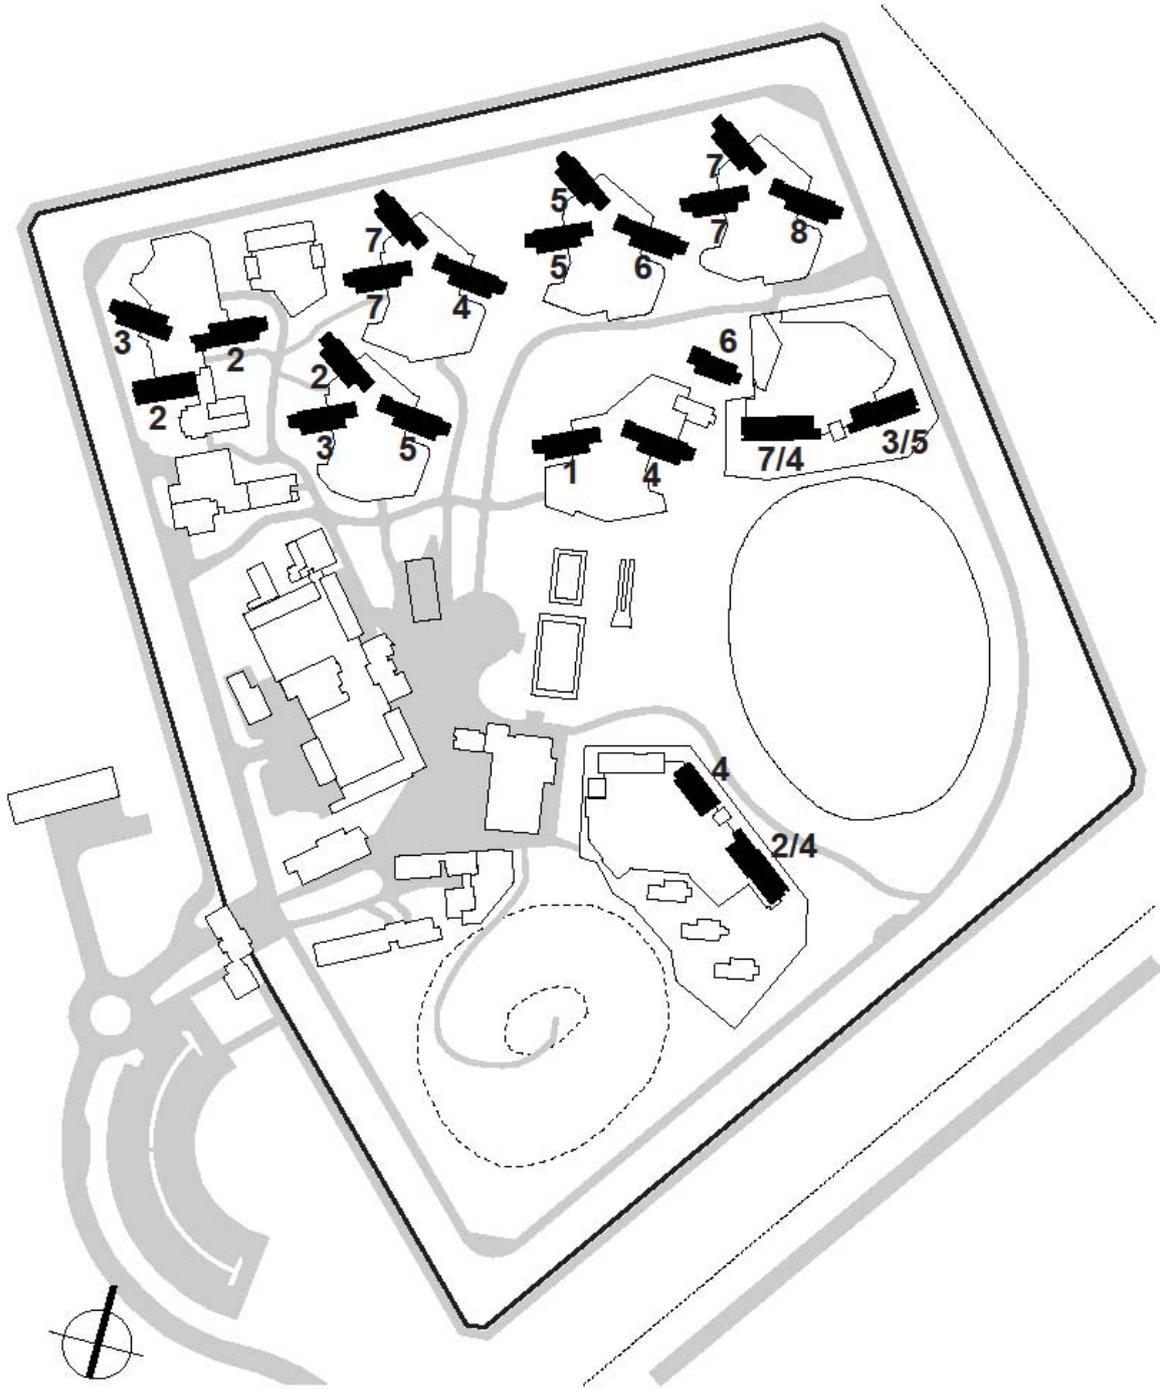
**Figure 6**  
*Site Damage*

Numbers and locations of Damaged / Unserviceable Cells

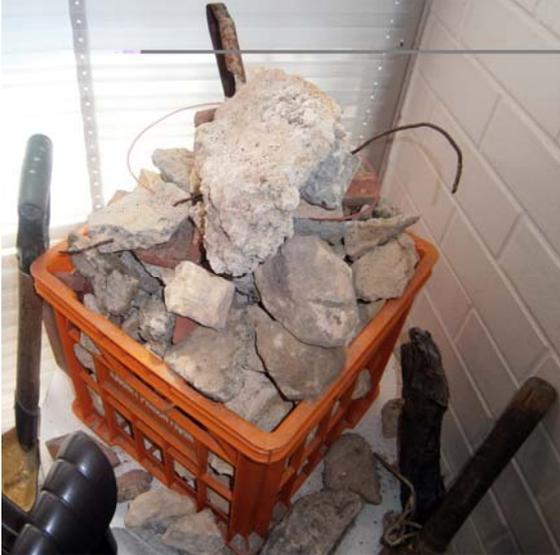
**Photo 38**

*Typical builder's rubble collected from around the site which was available to detainees in outdoor areas during the riot.*

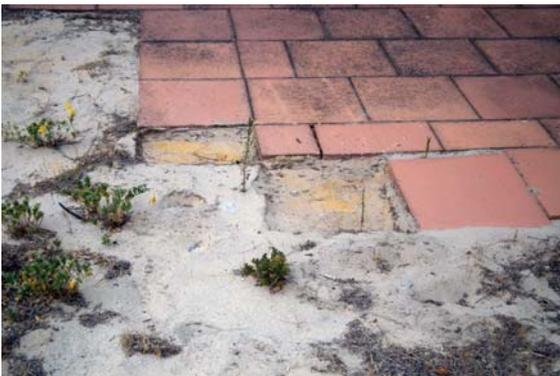
**Photo 39**

*Unfixed pavers available to detainees as tools to cause damage to the buildings during the riot.*

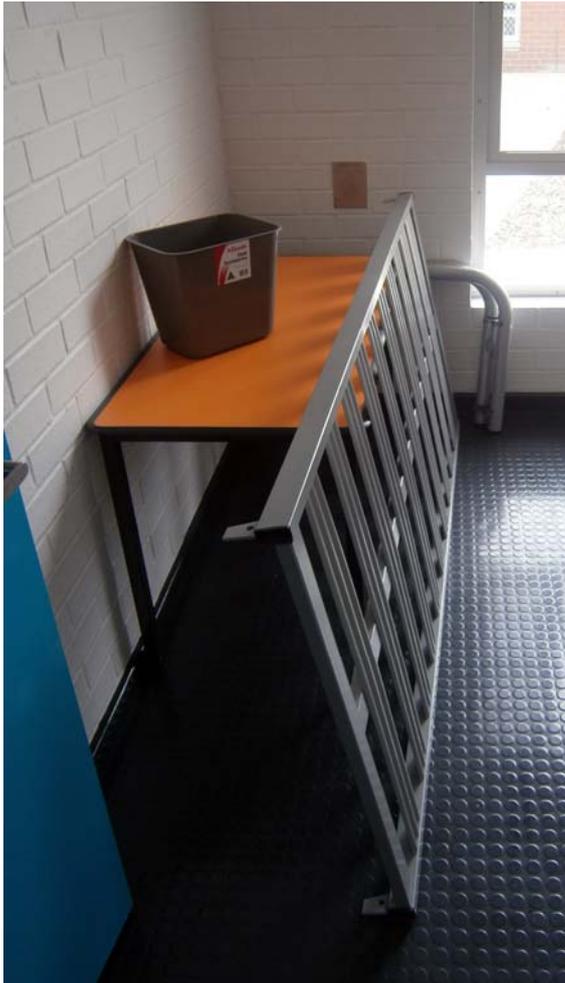
**Photo 42**

*New bed frames left unassembled in the self-care unit were accessed by detainees. Bed ends were utilised by detainees to cause damage to the buildings. .*

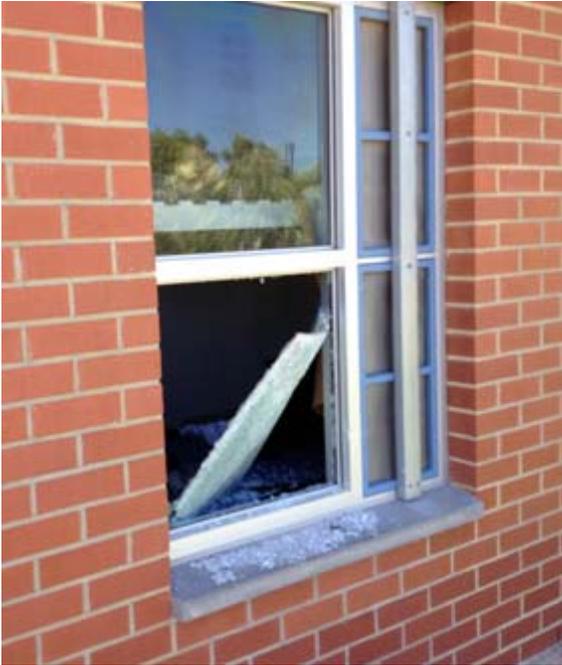
**Photo 43**

*External attack on cell window to free detainee – glazing panel dislodged into the cell space.*

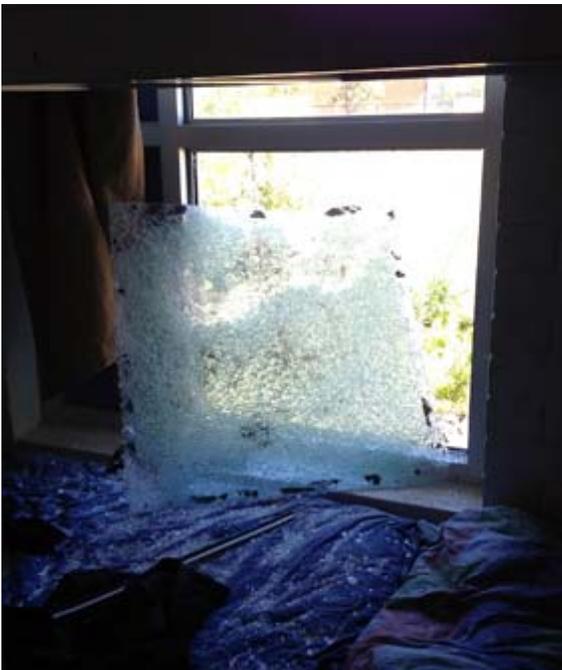
**Photo 44**

*External attack on cell window to free detainee – glazing panel dislodged into the cell space.*

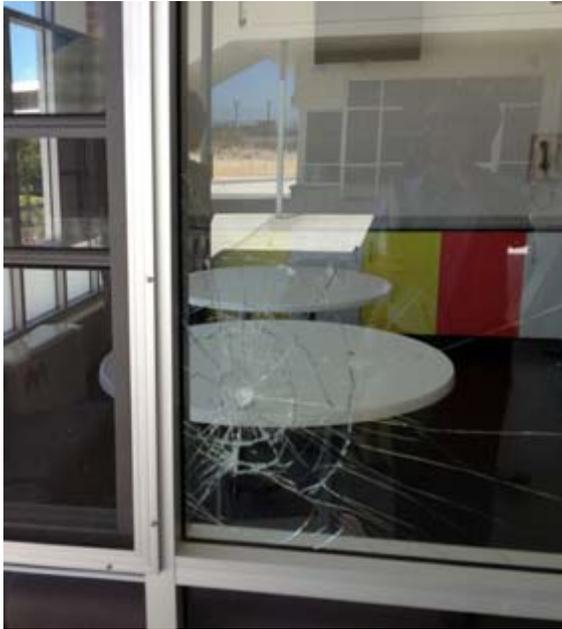
**Photo 62**

*Random attack to day space glazing at single storey girls unit.*

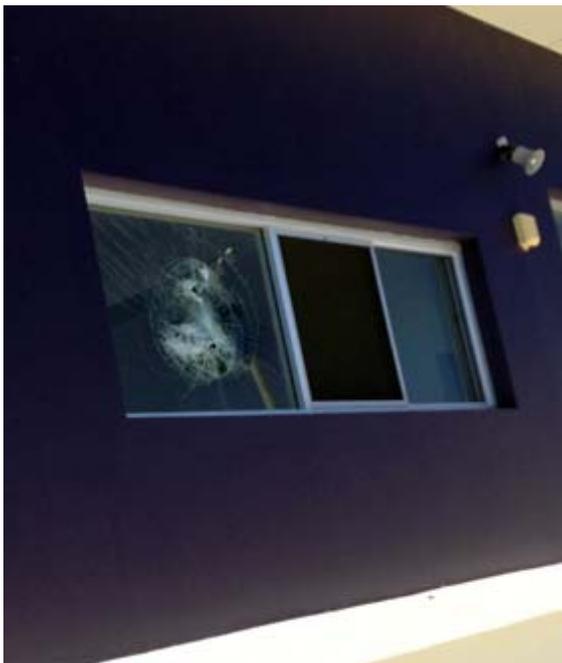
**Photo 63**

*Random attack to day space glazing - girl's unit upper storey.*

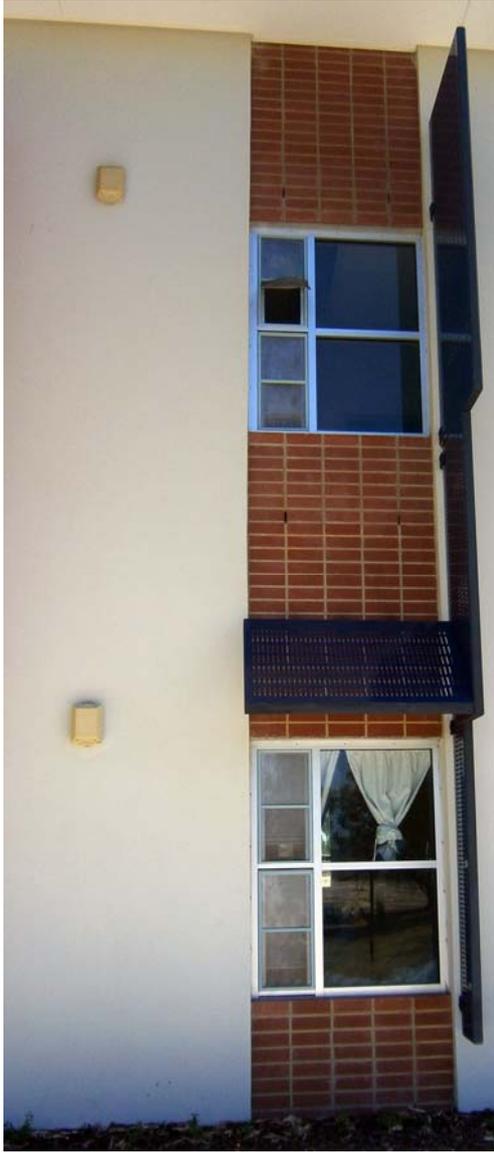
**Photo 66**

*Broken ventilation in Urquhart Unit breached by male detainee.*

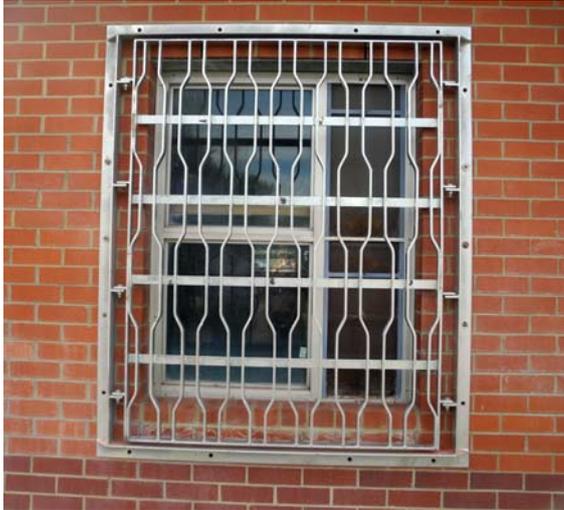
**Photo 72**  
*Retrofitting lozenge grille. This is the same type as that used within many of the adult prisons (refer to Appendix A for examples). This level of fortification will provide more than what should normally be required to secure the cell space from direct escape to the outside. However, it will not prevent external damage to the glazing.*

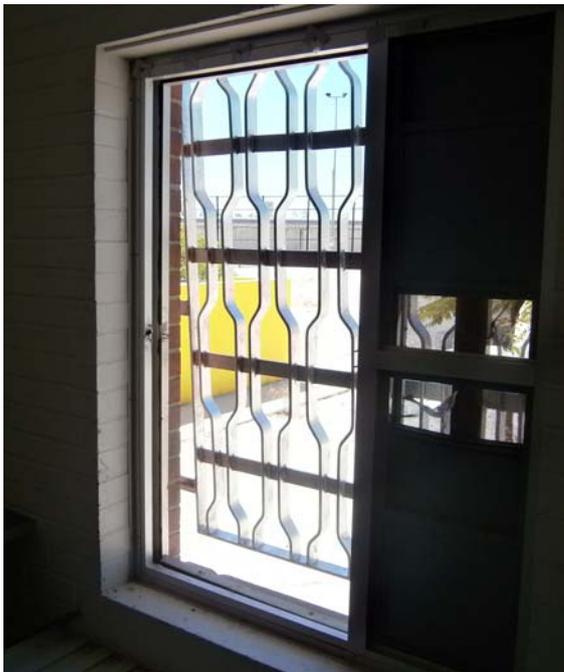
**Photo 73**  
*Retrofitting lozenge grilles from inside the cell. They diminish the outlook, particularly the oblique views.*

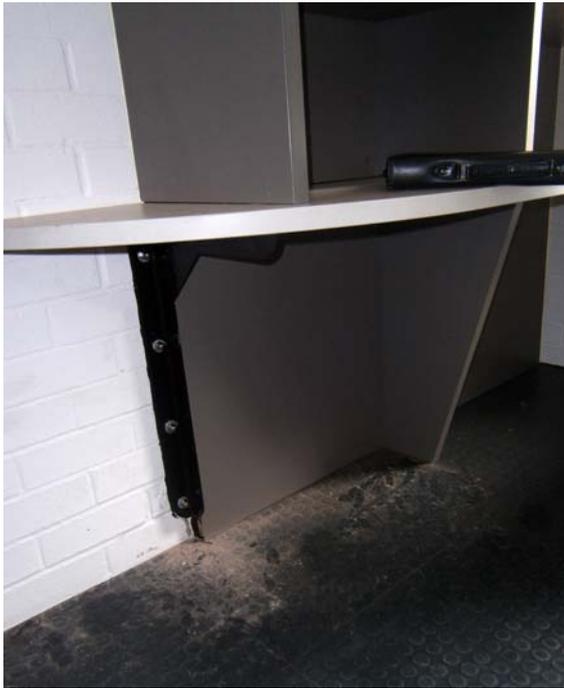
**Photo 75**

*MDF bench supports which were removed by detainees and used as breaching aids - in the process of being replaced with steel brackets.*

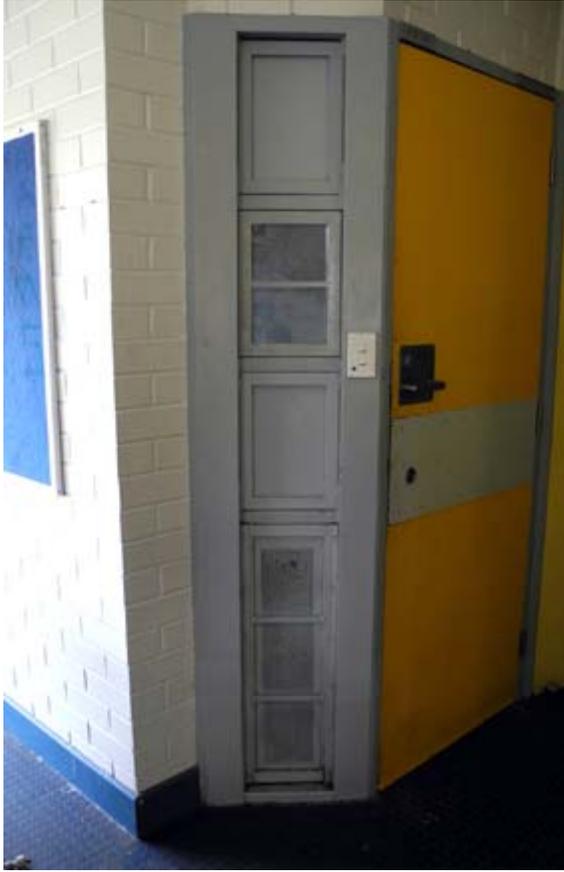
**Photo 76**  
*Steel bar fixed over glazed observation panel of the type that was breached during the riot (refer to Photo 75).*

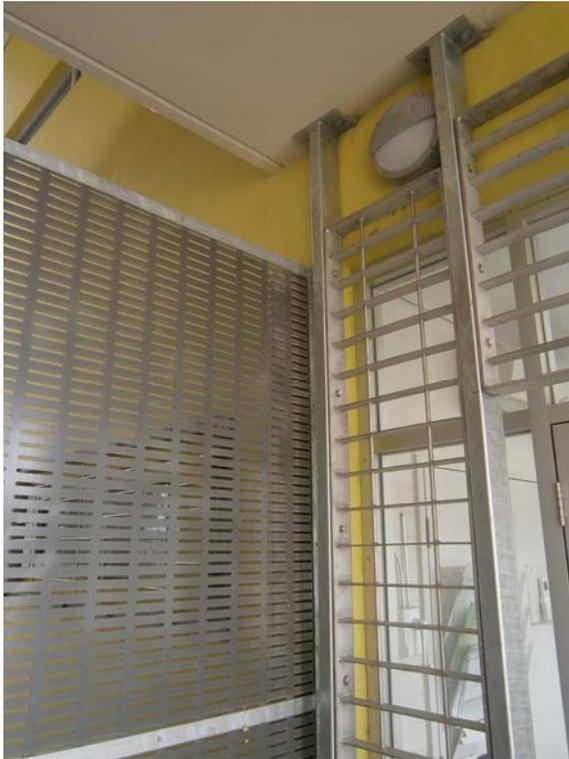
**Photo 82**  
*The retrofitted security grille has provided a ladder to facilitate access over the adjacent anti-climb management fence.*

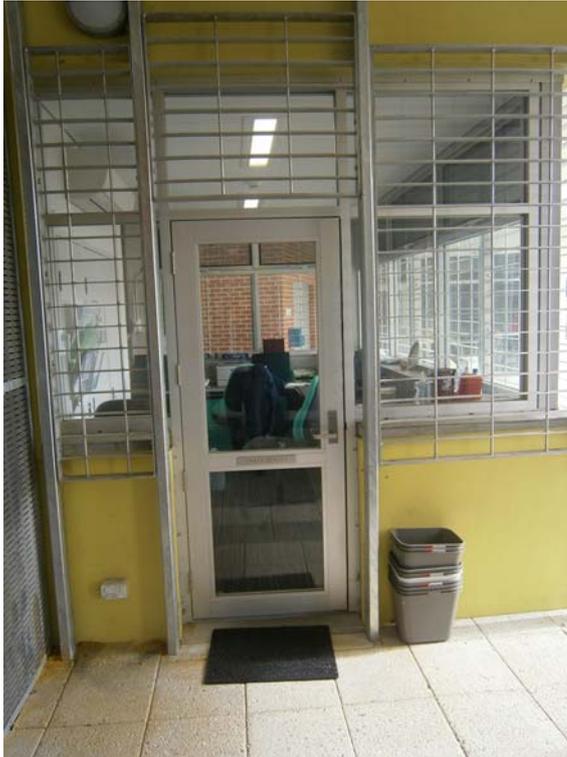
**Photo 83**

*The retrofitting of the bars around the unit office door does not add to the resistance against physical attack but adds hard infrastructure and reduces visibility and staff-detainee interaction.*
