OFFICE OF THE INSPECTOR  
OF CUSTODIAL SERVICES

Physical Infrastructure  
Review Paper

**Banksia Hill Directed Review  
August 2013**

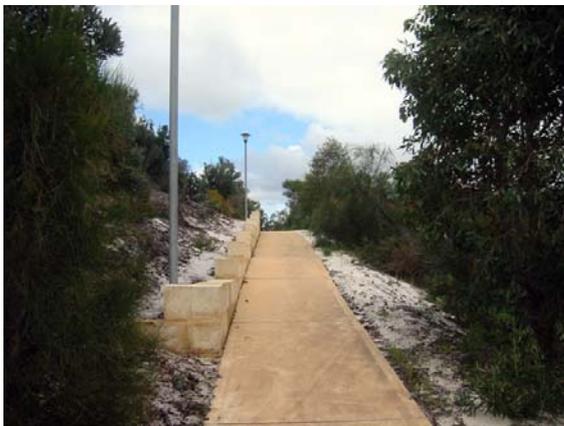
**Photo 10**

*Pathway to the Hill. It was intended that the Hill be used as part of a programmed activity for detainees, giving them access, under appropriately managed arrangements, to enjoy and engage with natural flora and to also gain an outlook of the surroundings. Access is currently cut off by a left over fence from previous construction activity – refer to Photo 12.*

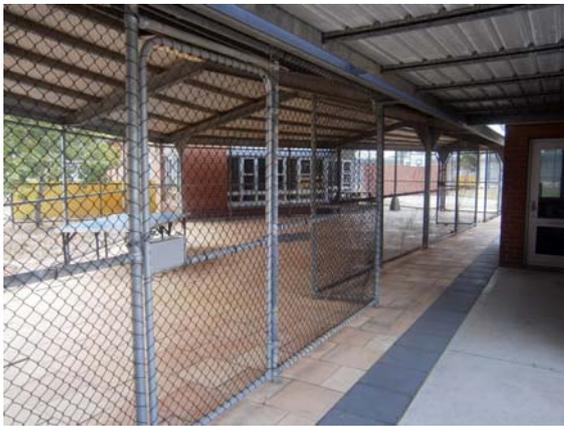
**Photo 16**

*Introduction of “cage” mesh fencing - central to the Harding Unit wings.*

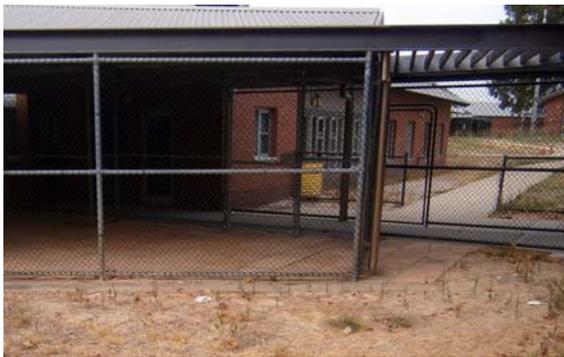
**Photo 17**

*Mesh fencing added to Harding Unit.*

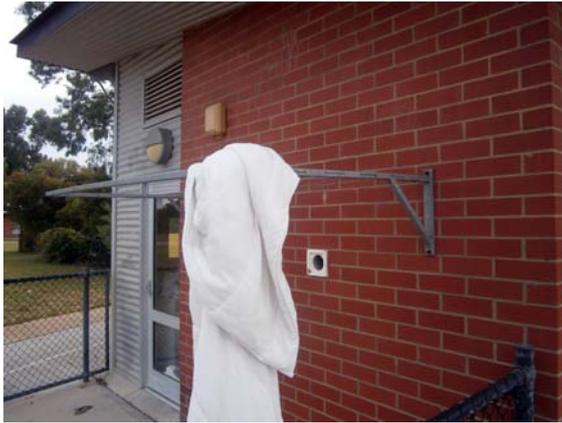
**Photo 24**  
*Drying frames vulnerable to removal by detainees.*

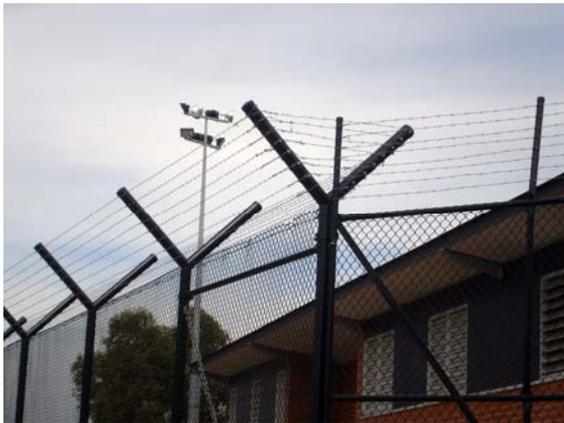
**Photo 27**  
*Detail of barbed wire topping to management fences.<sup>12</sup>*

<sup>12</sup> Photos 35 to 37 illustrate the ease with which boys scaled the fences despite these anti-climb measures.

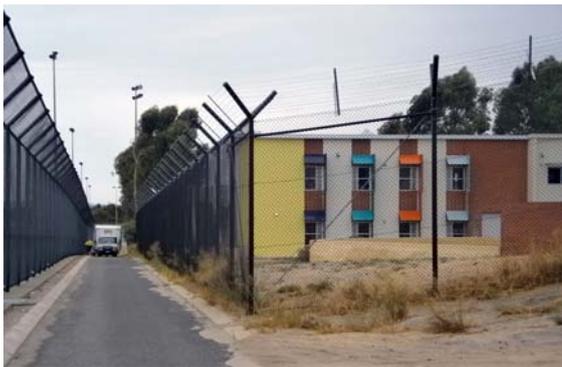
5.13 Photos 32 to 34 show the management fencing around the most recently constructed boys' unit at Banksia Hill. This fence type was easily scaled by detainees during the riot, rendering them as 'demarcation' rather than 'barrier' fences. The issues surrounding the adding of lethal layers to fences in juvenile facilities is covered elsewhere in the Inquiry.<sup>13</sup>

**Photo 33**  
*Inner perimeter service road.*

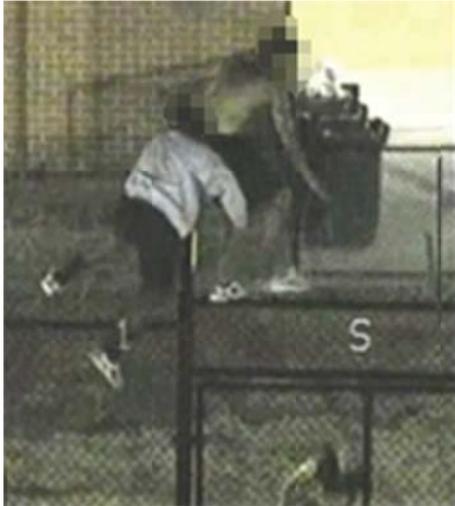
**Photo 35**

*An illustration that the frames of the fencing and gates provide ready foot- and hand-holds and are easily scaled.*

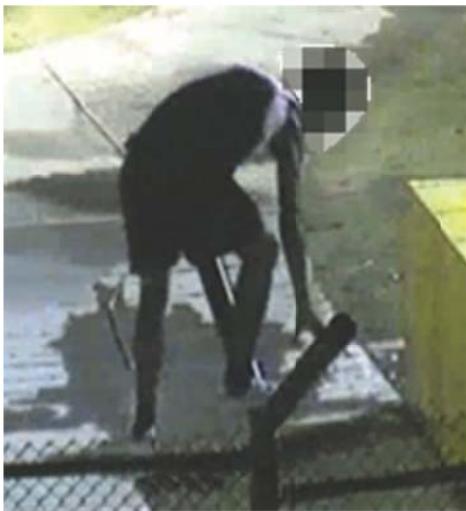
**Photo 36**

*This boy is four metres above the concrete ground surface and is oblivious to the risk of falling or wire entanglement.*

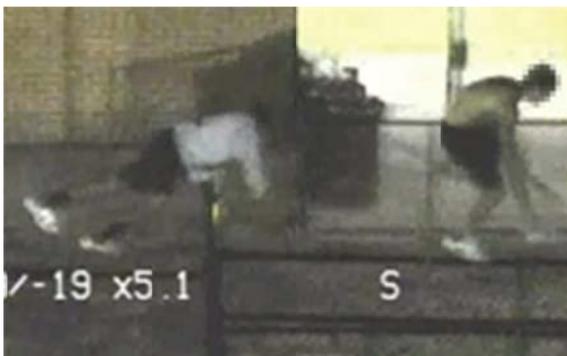
**Photo 37**

*CCTV footage showed the fences being scaled at speed.*

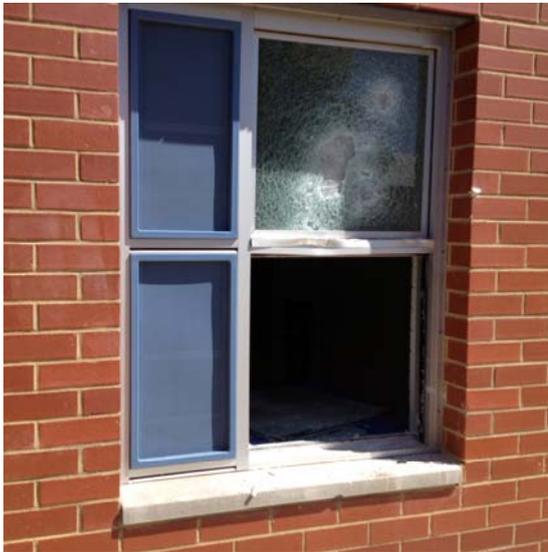
**Photo 46**  
*Harding Unit Wing.*

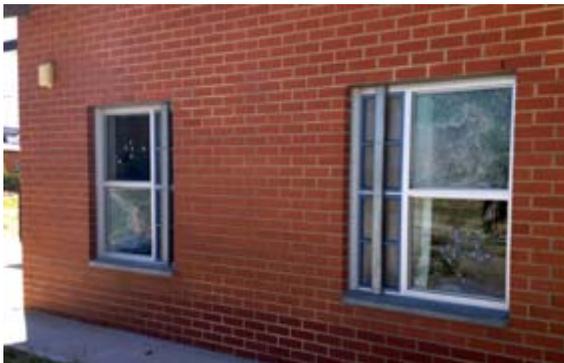
**Photo 47**  
*Shattered glazing to cell windows – external attack.*

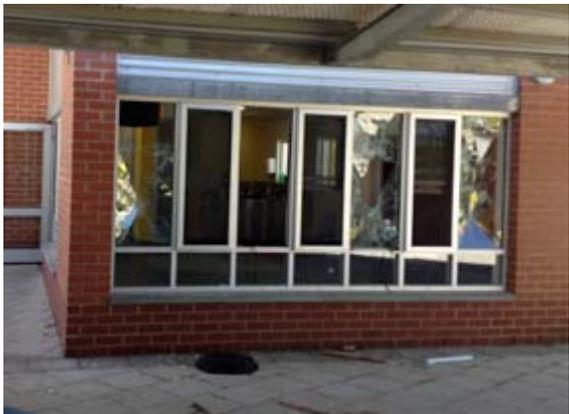
**Photo 59**  
*Shattered laminated glazing to  
day space of living unit.*

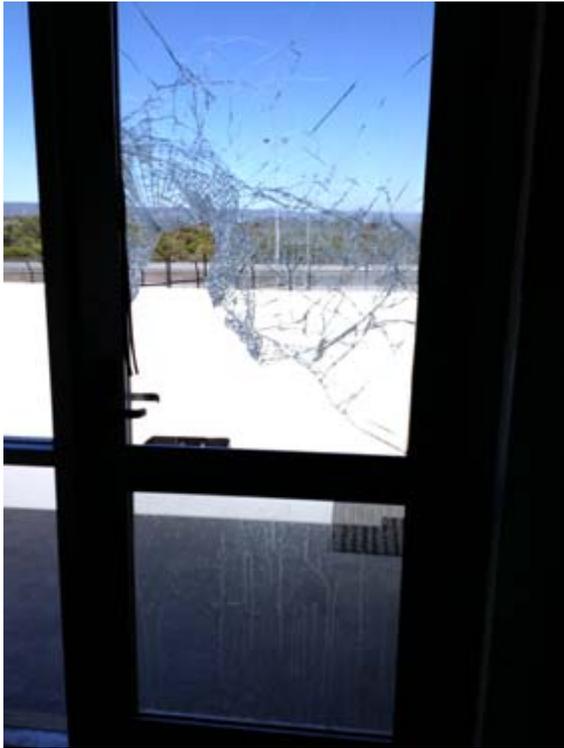
**Photo 64**  
*Door to laundry at girl's unit,  
upper level.*

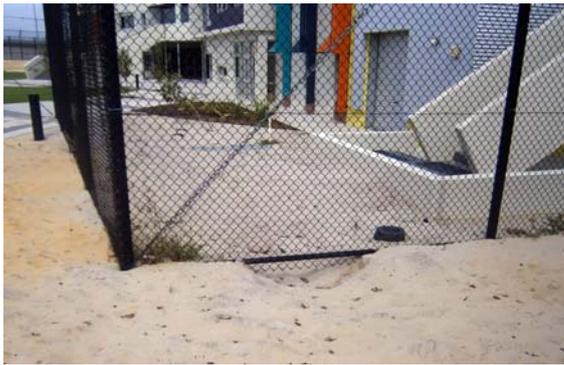
**Photo 65**  
*Tunnelling under management  
fence at boys unit. Absence of  
concrete plinth.*

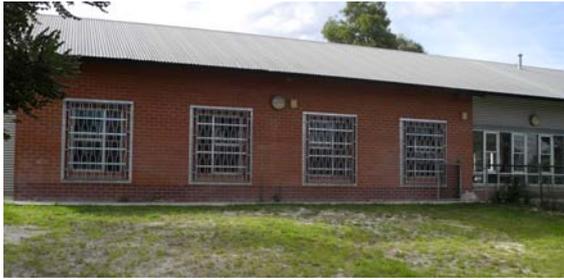
**Photo 71**  
*Retrofitting of security grilles to cell windows.*

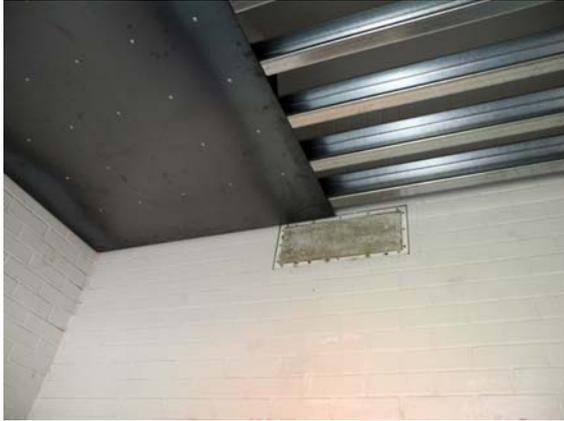
**Photo 74**

*Retrofitting of horizontal ceiling framework and linings into cells with sloped ceilings. This will generate a large concealed ceiling space and eliminate the thermal value a high volume provides in helping to dissipate heat.*

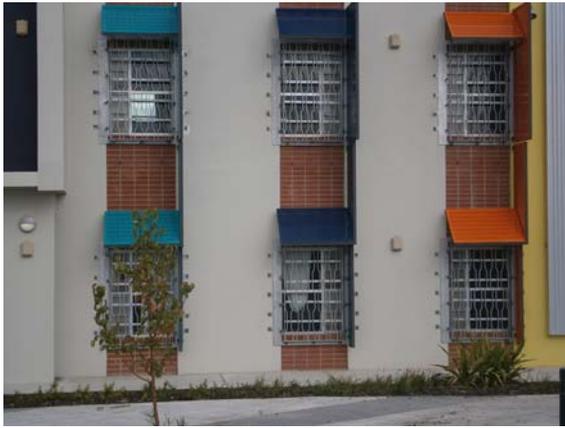
**Photo 78**  
*Grilles retrofitted to Urquhart Unit cell windows.*
